Mode and cause of failure of a Bevel gear-A review

Hemanshu D. Joshi¹, K. D. Kothari²

Keywords: *Bevel gear, failure analysis, mode of failure, cause of failure.*

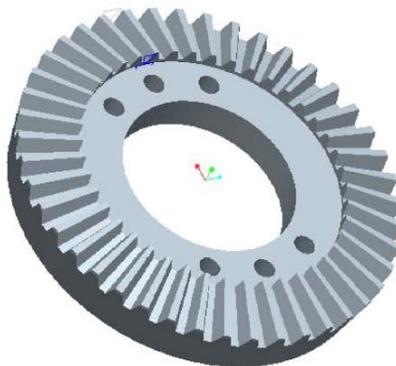
A straight bevel gear is shown in Figure-1.1. It is used when power is to be transmitted between two intersecting shaft and teeth are formed on conical surfaces.

Fig.1.1 Bevel gear

If teeth are cut in the form of circular arc so the tooth is no longer straight, then it is known as spiral bevel gear. And when shafts are offset and nonintersecting hypoid gears are used. It is quite similar to spiral bevel gears.

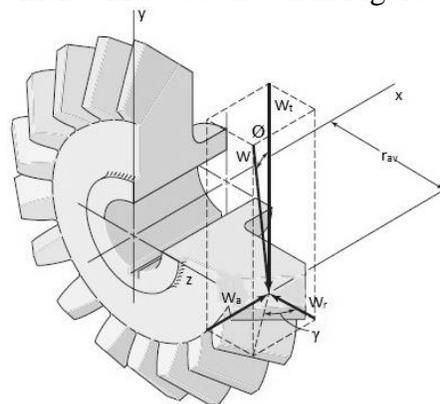
There are three forces which act on a particular tooth of the bevel gear. The resultant of these three forces is indicated by W which will act as shown in Figure-1.2.

Fig.1.2 Bevel gear [3]

Due to W_t force the gear will have the rotation motion and it represents tangential force. W_r and W_a forces represent the radial force and axial force respectively. These three forces are acting perpendicular to each other and resultant of these three forces will represent W . [3]
